Ceramic Applications in Turbine Engines

Harold E. Helms, Peter W. Heitman,
Leonard C. Lindgren, and Samuel R. Thrasher
Allison Gas Turbine Division
General Motors Corporation

October 1984

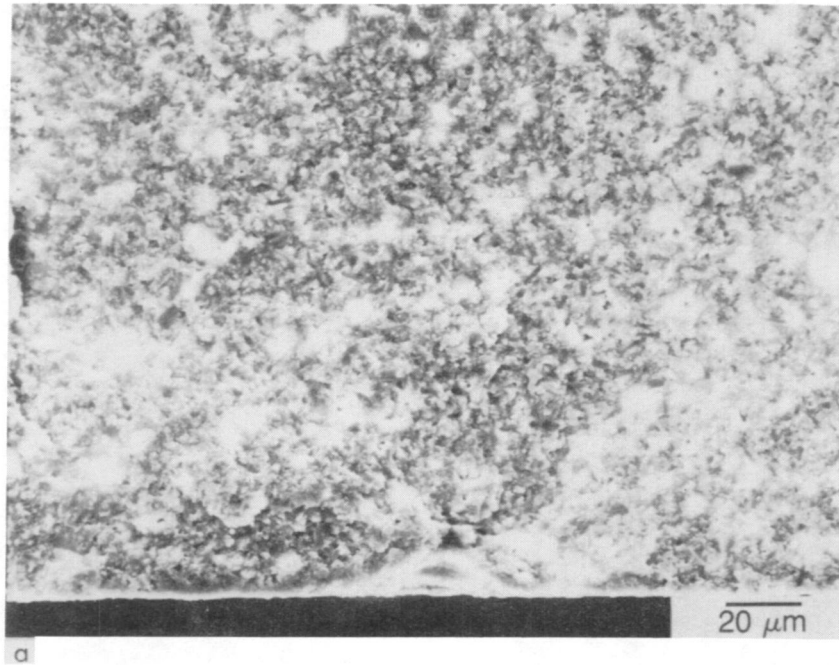
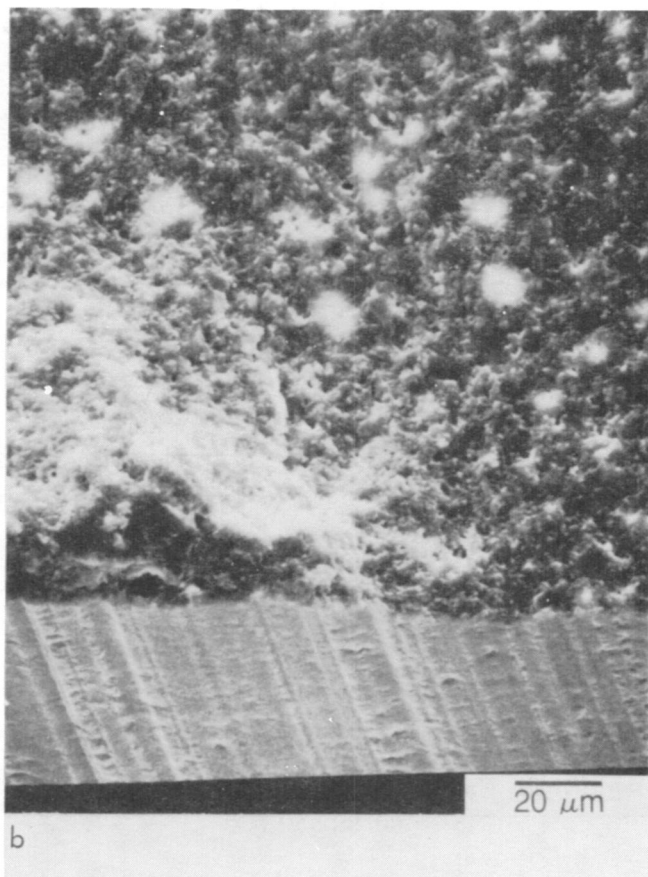
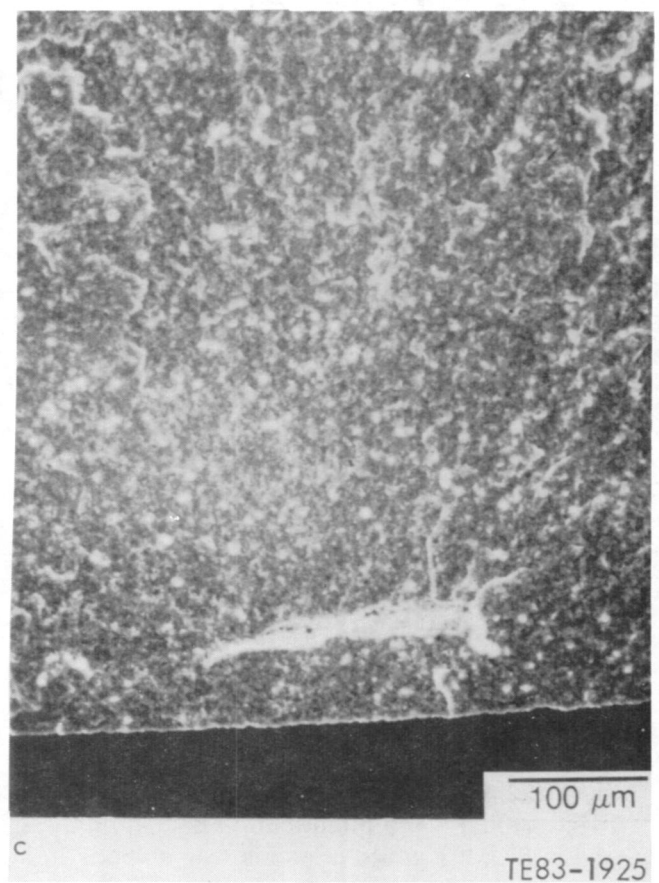
Figure 120. Typical strength-controlling defects observed in NGK Spark Plug EC-129 sintered Si_3N_4 test bars at room temperature: (a) surface pore, (b) surface crack, and (c) internal pore.

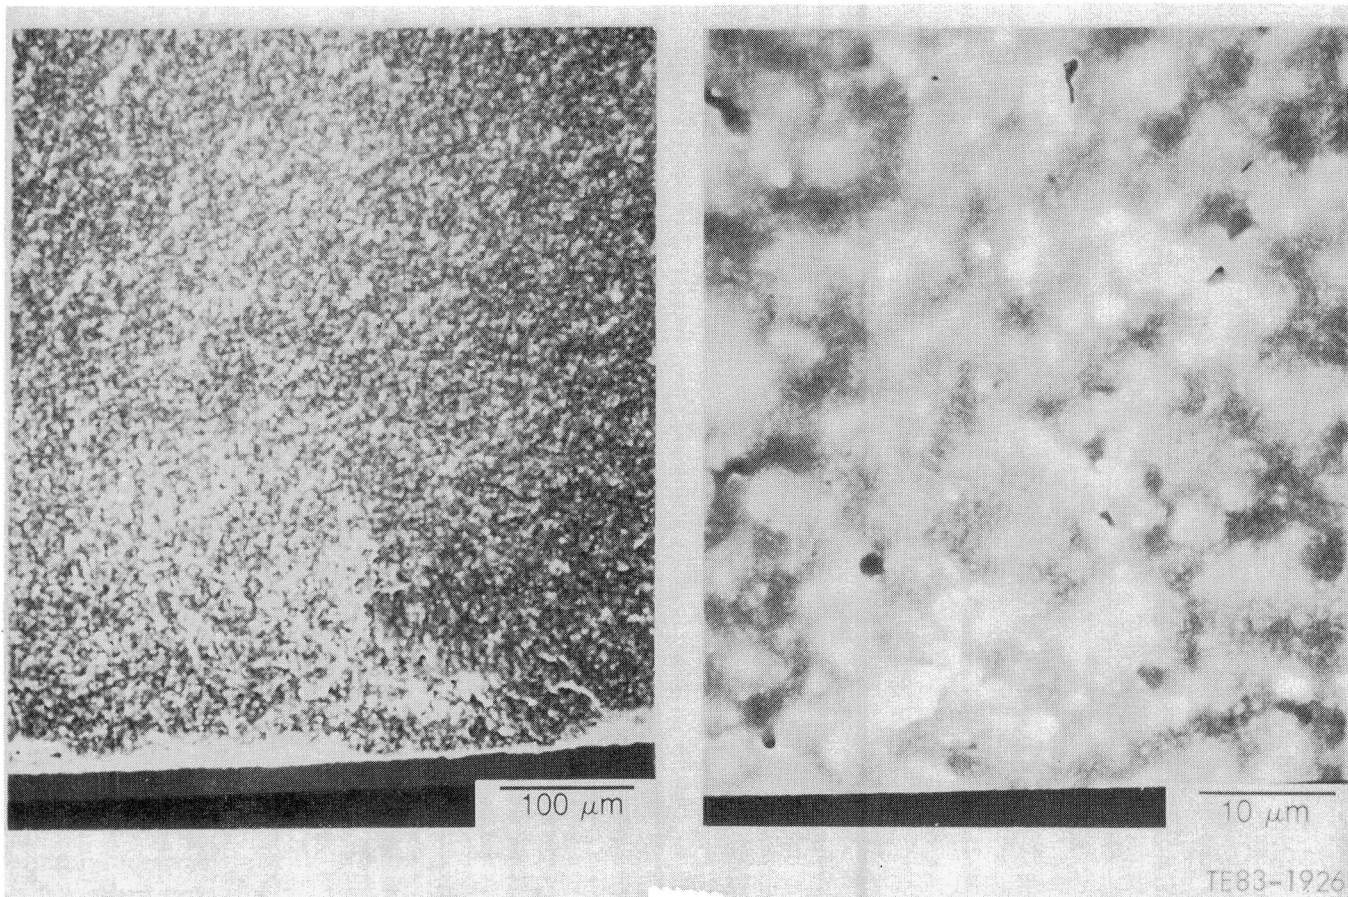
Figure 121. Fracture surface of NGK Spark Plug EC-129 sintered Si_3N_4 test bar at 1100°C (2012°F).

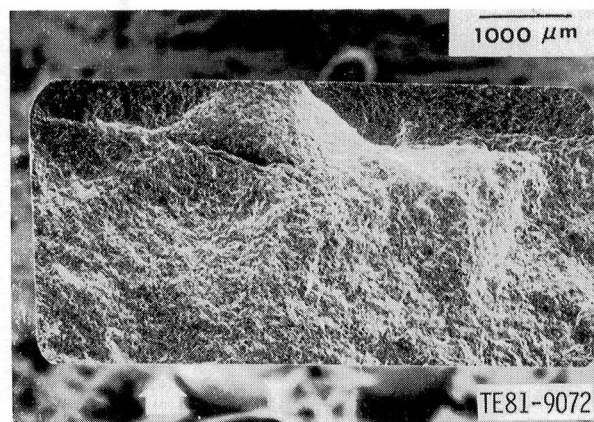
standard deviation of 36.78 MPa (5.33 ksi). All specimens failed from surface sites in both the as-fired and machined materials. A typical fractograph of a failure origin is shown in Figure 123.

Figure 123. SEM fractograph of an Annawerk RBSiC test bar; arrow indicates failure initiated at surface site.

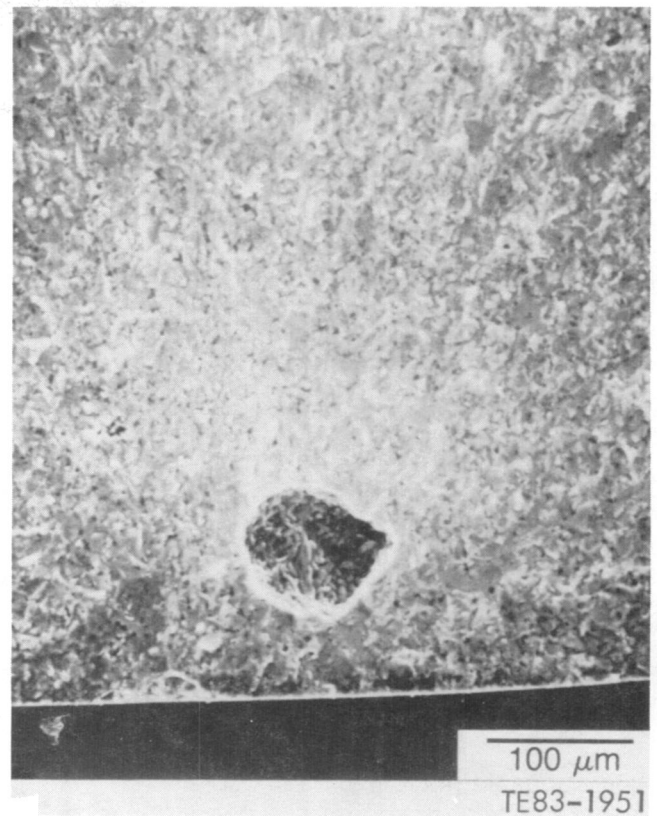
averaged 316.92 MPa (45.97 ksi) with a standard deviation of 61.91 MPa (8.98 ksi). Internal pores, such as the one in Figure 125, were identified as the fracture origins in all instances.

Figure 125. Typical failure origin (internal pore) observed in machined CBO sintered alpha SiC vane test bars.

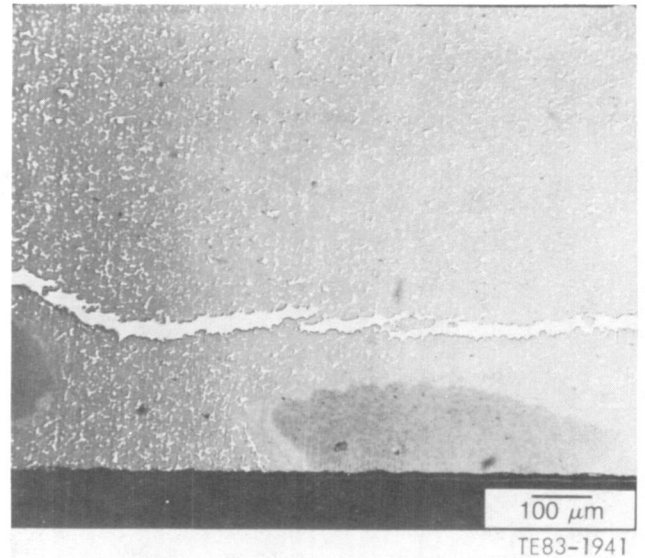
revealed the presence of laminations in the free silicon and large internal and surface agglomerates (300 μm), composed primarily of silicon with iron impurities and traces of titanium, sulfur, and calcium (see Figure 126). Several samples also exhibited fine particles of silicon and iron interspersed in the network of free silicon, as shown in Figure 127. The average room temperature fracture strength of test material with an as-fired surface condition measured 267.03 MPa (38.73 ksi) with a standard deviation of 47.29 MPa (6.86 ksi). Surface flaws, as shown in Figure 128, were identified as the primary strength-controlling defects in all of these specimens. The average MOR of test bars with a longitudinally ground surface measured 332.12 MPa (48.17 ksi) with a standard deviation of 69.48 MPa (10.09 ksi). The primary strength-controlling defects in these test bars were internal and surface inclusions of silicon and iron; the secondary defects were surface flaws and pores, shown in Figure 129.

Figure 126. Microstructure of Pure Carbon Refel RBSiC 2070°F vane qualification test bar with silicon lamination and large surface agglomerate.

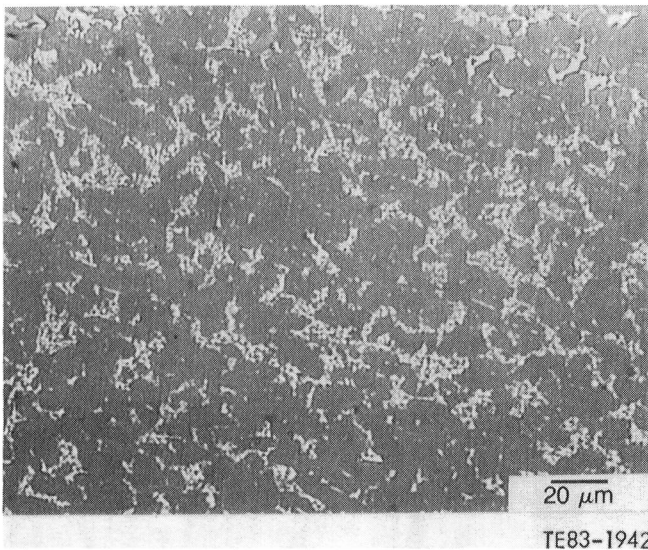
Figure 127. Microstructure of Pure Carbon RBSiC with fine particles of silicon and iron in the free silicon.

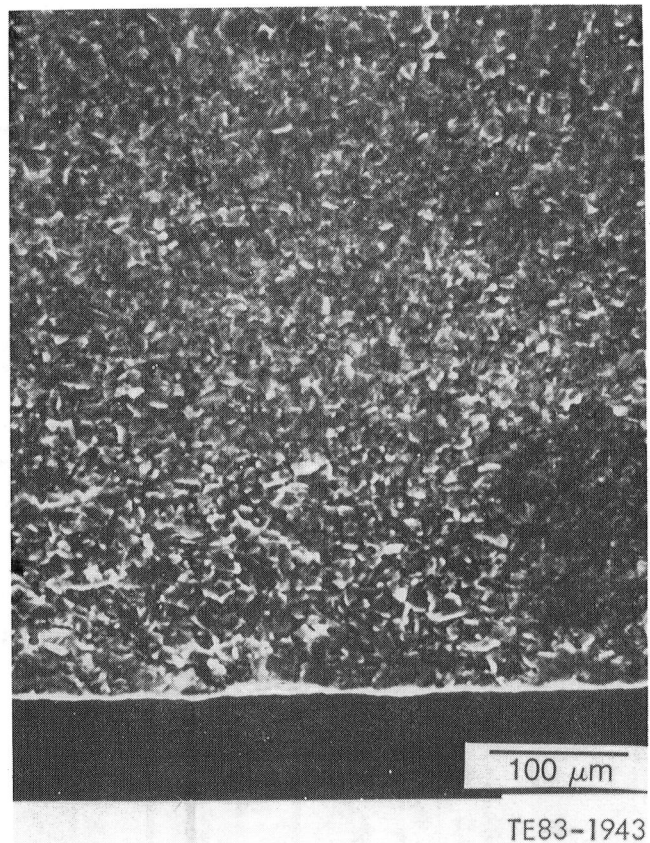
Figure 128. Typical strength-controlling defect (surface flaw) observed in Pure Carbon vane test bars.

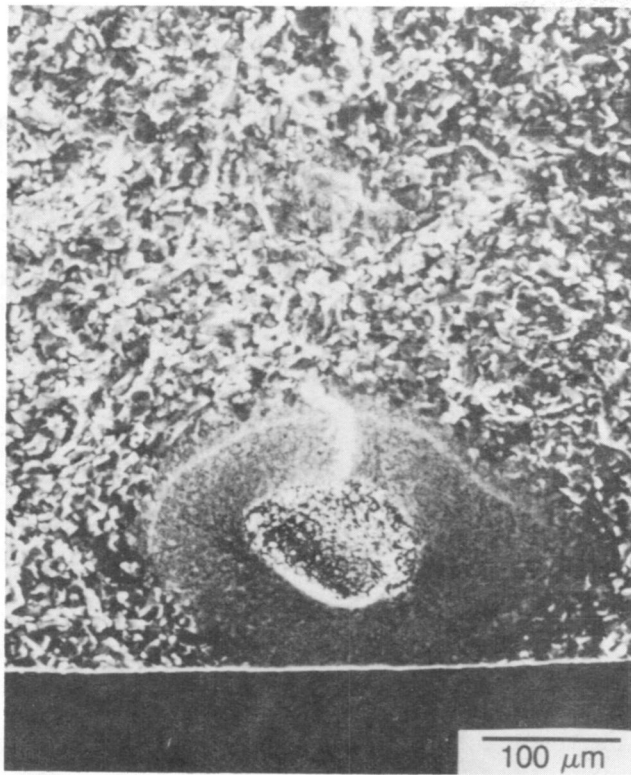
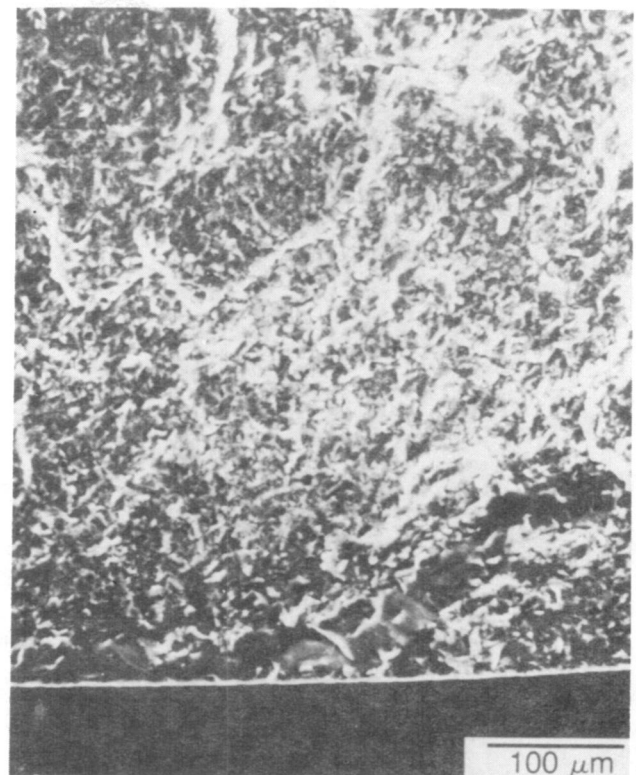
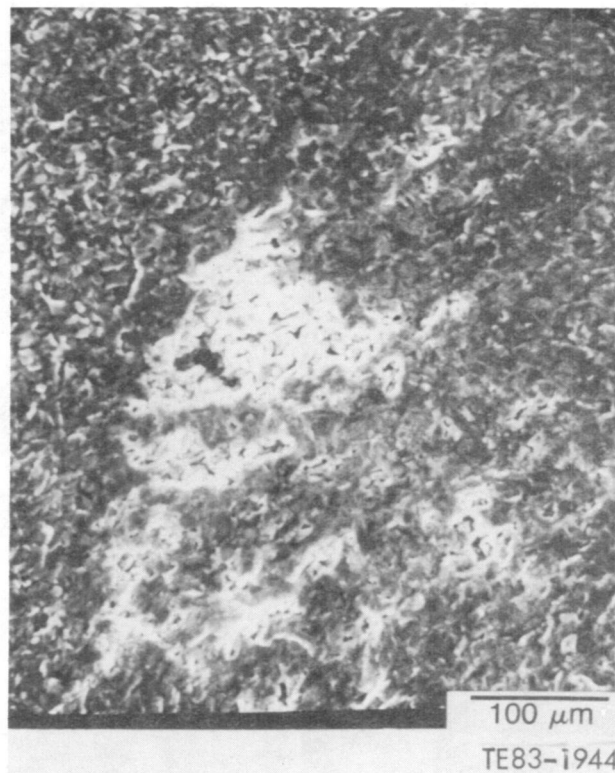
Figure 129. Examples of typical strength-controlling defects observed in machined Pure Carbon vane test bars: (a) inclusion with pore, (b) surface flaw, and (c) internal pore.

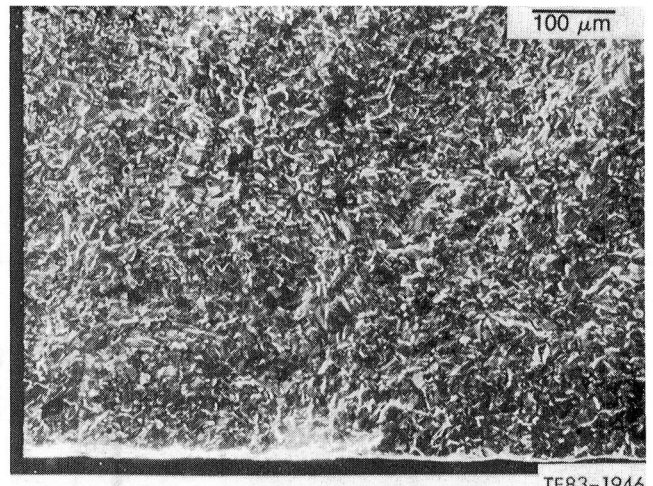
with an as-fired surface condition measured 294.10 MPa (42.66 ksi) with a standard deviation of 36.12 MPa (5.24 ksi). All failures of these specimens initiated from surface flaws, shown in Figure 131. Test material with a machined surface condition registered an average MOR of 337.12 MPa (48.90 ksi) with a standard deviation of 49.50 MPa (7.18 ksi). Graphite inclusions, both external and internal, were identified as the fracture origins in all of these samples (see Figure 132).

Figure 131. Failure origin (surface flaw) of as-fired inner vane support ring test bars.

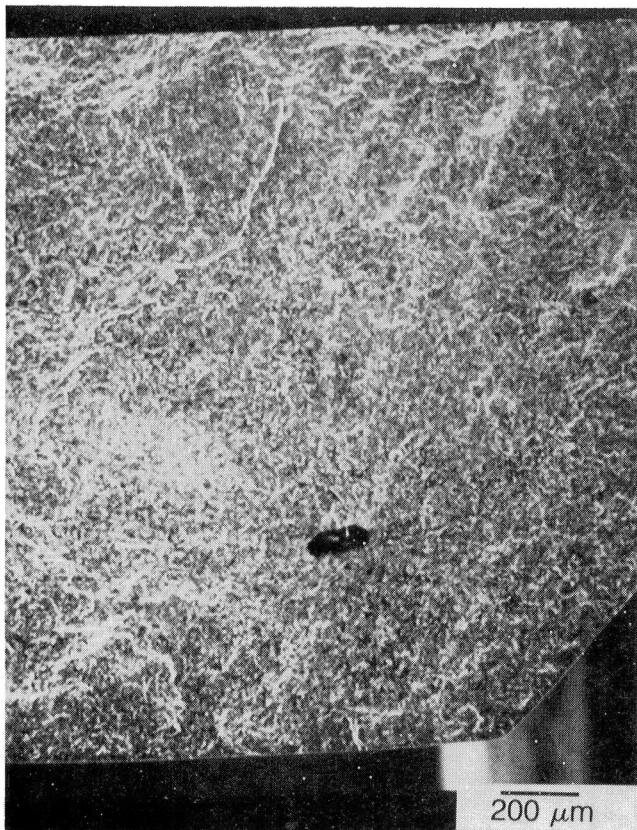
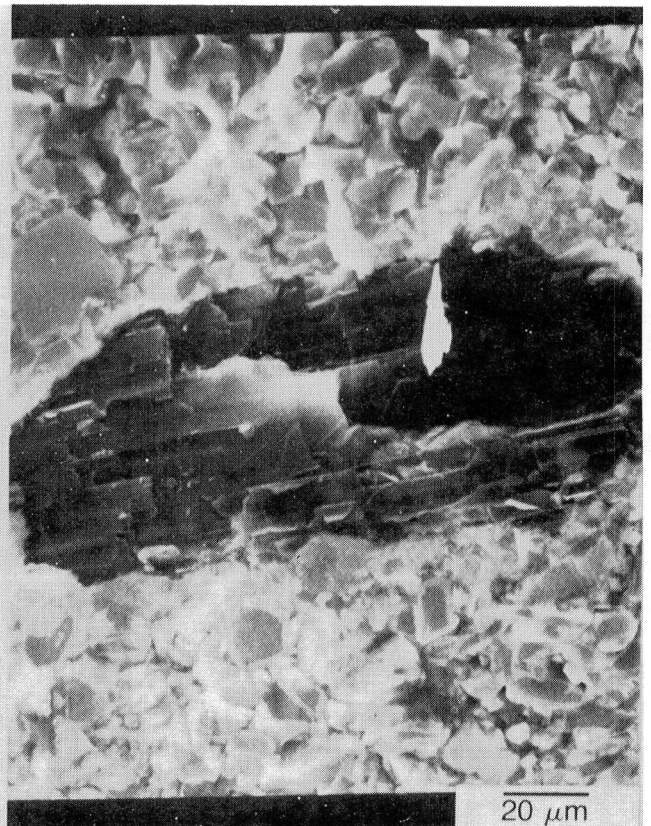
Figure 132. Failure origin (internal graphite inclusion) of Pure Carbon RBSiC test bars with machined surface condition.

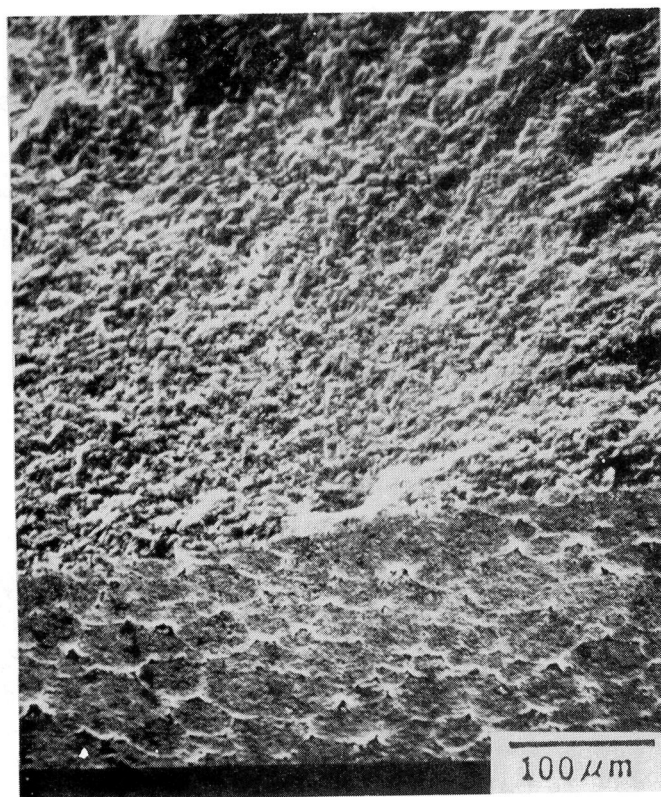
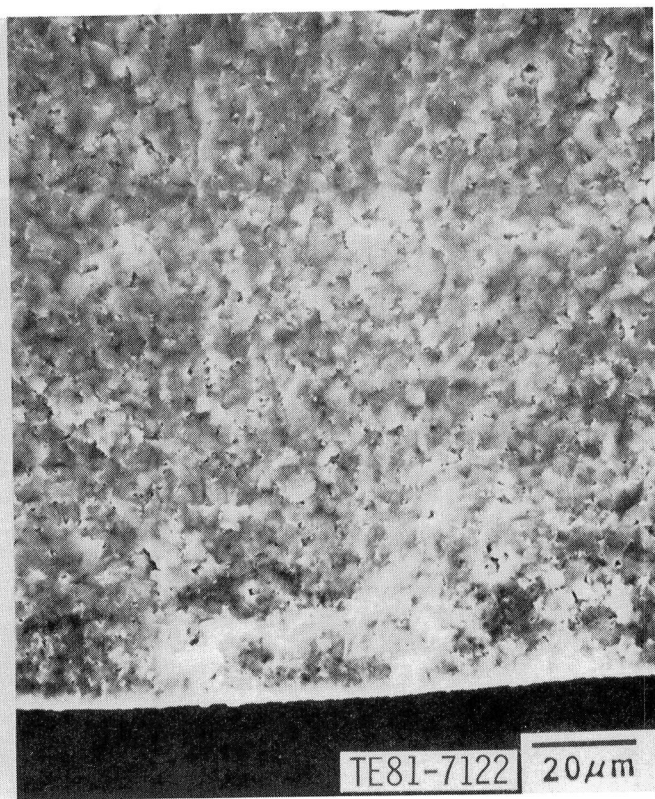
Figure 136. Typical strength-controlling flaw (surface crack) in Kyocera SC-201 test bars.

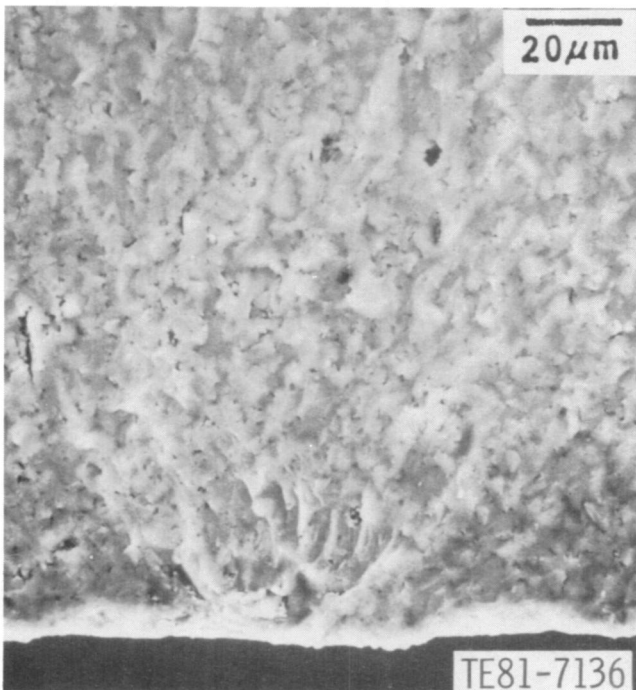
these bars were the surface and internal pores typically observed in this material. However, a number of test bars failed as a result of flaws (see Figure 138), which appeared to be surface cracks.

Figure 138. Strength-controlling critical flaw (surface crack) in as-fired CBO alpha SiC outer vane support ring bars.

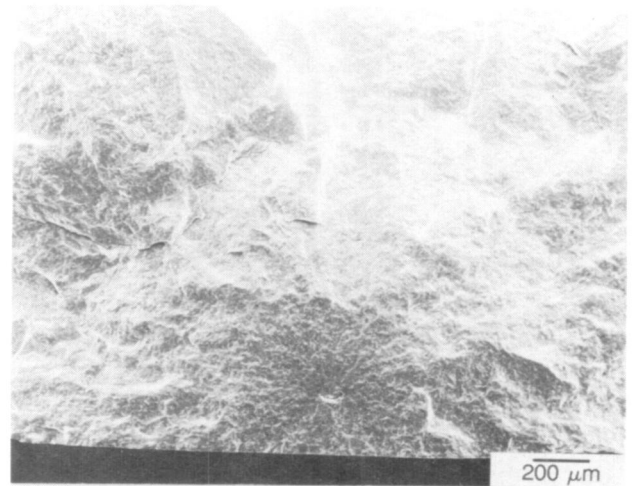
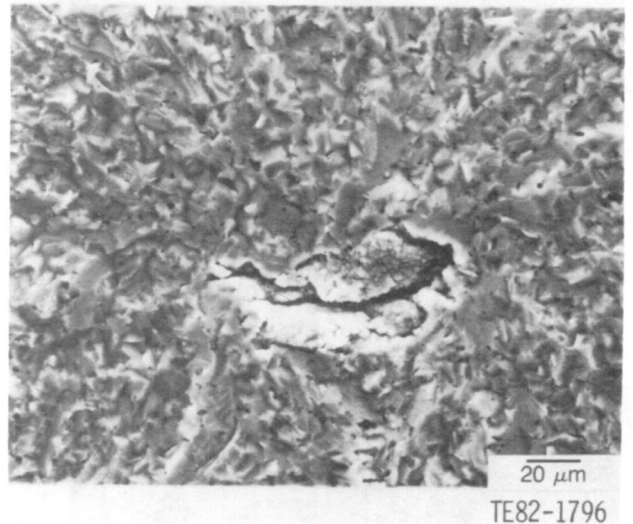
pressure of 15.2 MPa (2200 psi), which corresponds to a peak calculated stress of 213.0 MPa (30.9 ksi). Fracture initiated from an internal pore located on the aft portion of the inside diameter of the ring, as illustrated in Figure 139.

Figure 139. SEM fractograph of failure origin (internal pore) in CBO sintered alpha SiC outer vane support ring.

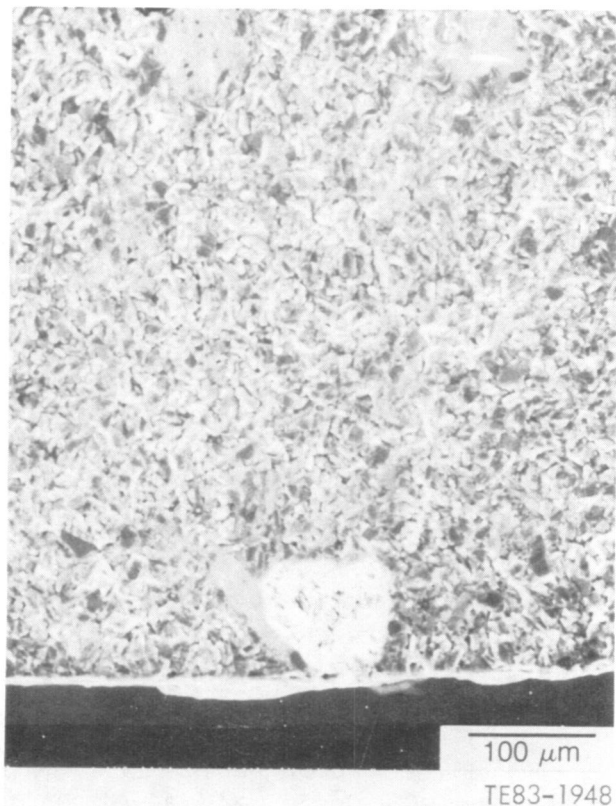
Figure 141. Typical failure origin (surface pore) observed in test bars cut from Pure Carbon RBSiC outer vane support ring.

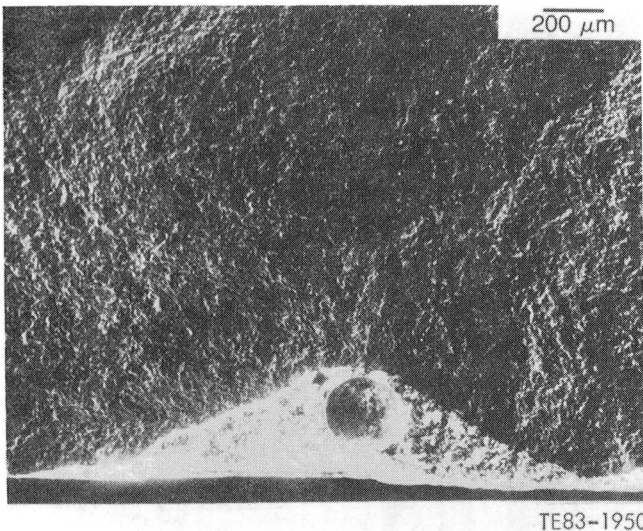
Figure 144. Pure Carbon RBSiC test bar showing foreign material (barium and sulfur) adjacent to the as-fired surface.

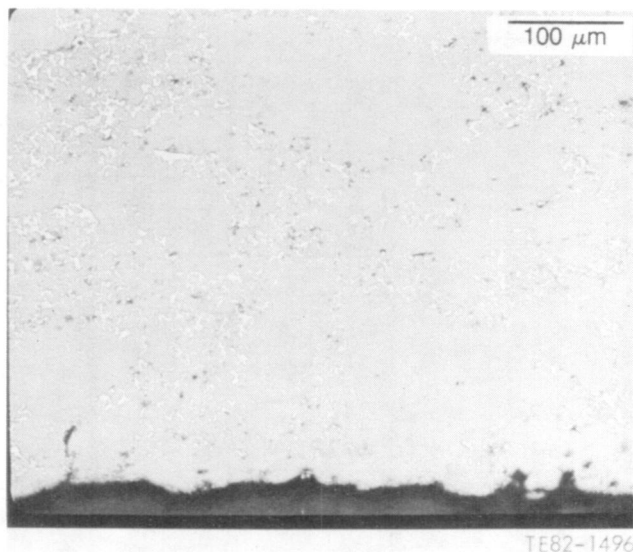
Figure 146. Microstructure of Norton NC-430 plenum test bars with a layer of SiC on the as-fired surface.

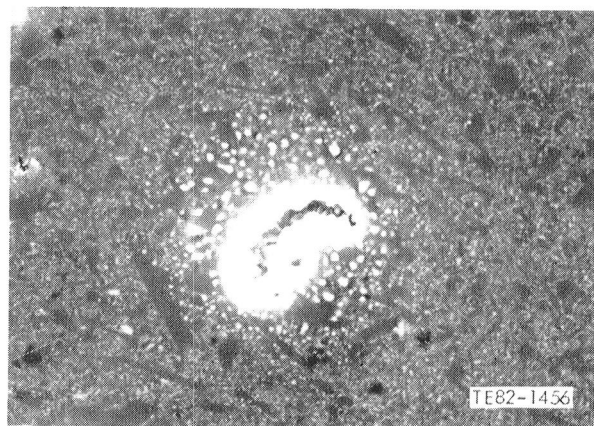
Figure 149. Subsurface defect (iron silicide inclusion) identified in GTE Si_3N_4 blade test bars.

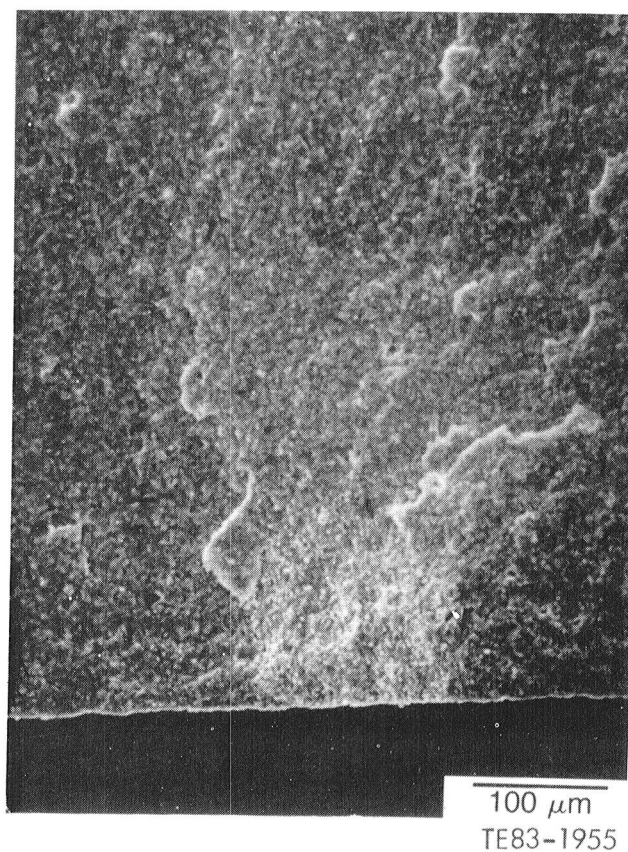
a standard deviation of 54.63 MPa (7.92 ksi). Low-density pockets and pores, shown in Figure 150, were identified as the primary strength-controlling defects. Bars tested with a machined surface condition recorded an average strength of 438.12 MPa (63.54 ksi) with a standard deviation of 67.44 MPa (9.78 ksi). All fractures of these specimens initiated from surface low-density pockets and pores.

Figure 150. Typical strength-controlling flaw (low-density pocket) observed in GTE AY6-404 Si_3N_4 blade test bars.

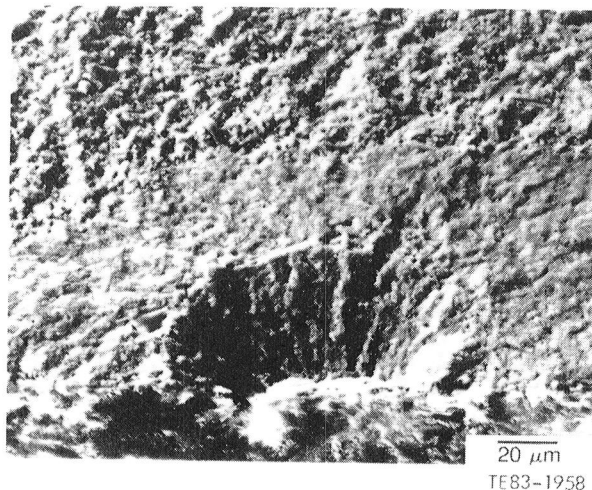
are shown in Figures 151 and 152. The average failure speed of the 10 blades machined at Crafts was 48,730 rpm—equivalent to 132.0% of design speed. The erratic nature of the failure locations (2 attachment, 5 stalk, 2 platform, and 1 airfoil) was attributed to a high frequency (80%) of atypical fracture origins, i.e., shell-like surface cracks, as in Figure 153. These artifacts were the result of an abrasive cleaning operation (grit blasting) performed on the blades after sintering to enhance the surface finish. This operation has been omitted in all subsequent blade fabrication. The average failure speed of the eight blades machined at MPS (two blades were broken during machining) was 52,300 rpm (141.7% design speed). Pores were identified as the primary strength-controlling defects, with only two blades failing from the shell-type surface cracks mentioned earlier in the section.

Figure 153. Atypical failure origins (shell-like surface cracks) observed in GTE AY6-404 Si_3N_4 blades.

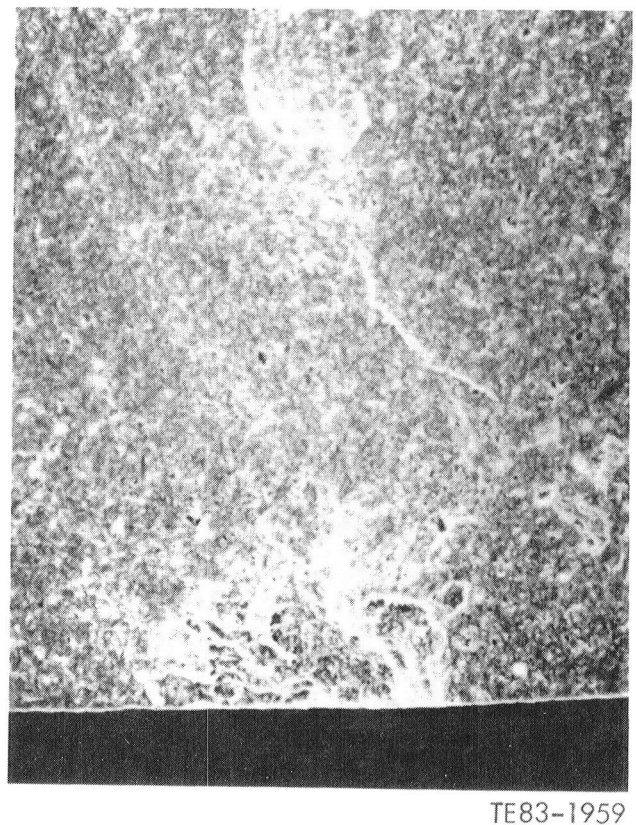
of 485.06 MPa (70.35 ksi) was measured. Surface low-density regions and pores, shown in Figure 154, were identified as the primary strength-controlling flaws. Thus, while spin-test performance to date is considered excellent, the significant decrease in strength noted in the interior of the blades compared with that obtained from the surface indicated that additional development activities were required to enhance blade uniformity.

Figure 154. Surface low-density regions and pores, identified as the failure origins in test material cut from the interior of the dovetail of GTE AY6-404 Si_3N_4 blades.

To address the difficulties encountered with internal low-density regions previously observed in the initial shipment of GTE blades, a follow-on order for an additional 180 blades and 100 injection-molded Si_3N_4 test bars was placed. An updated process specification, AY6-405, which incorporates a modified binder system with improved binder burn-out characteristics, was developed. A thermosetting material, which was found to impart a beneficial rigidizing effect to the molded parts, was added.

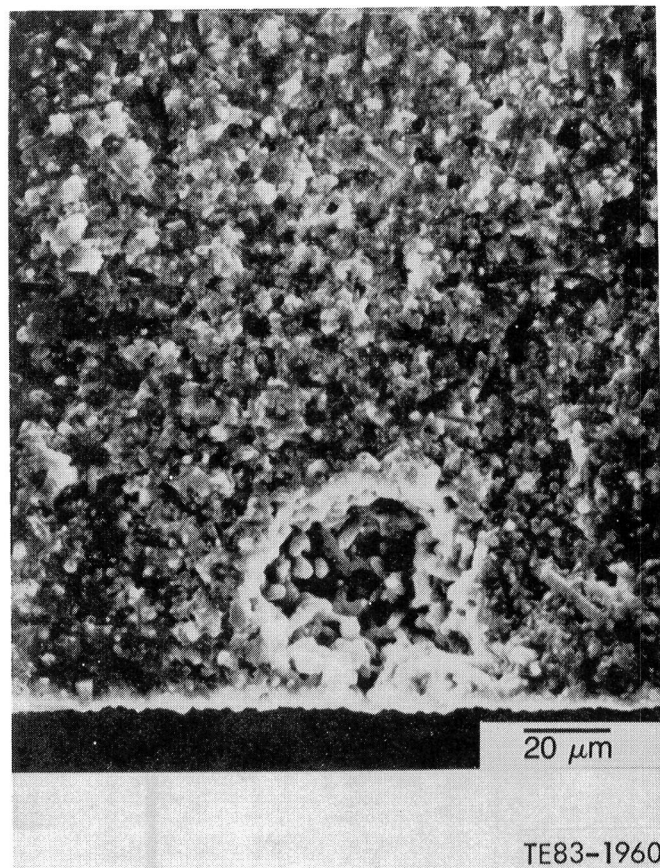
The average room-temperature fracture strength of test material with an as-fired surface condition measured 542.77 MPa (78.72 ksi) with a standard deviation of 65.23 MPa (9.46 ksi). Bars with a machined surface condition exhibited an average strength of 617.03 MPa (89.49 ksi) with a standard deviation of 65.78 MPa (9.54 ksi). These values represent the highest strengths obtained to date for any GTE injection-molded Si_3N_4 material. The primary strength-controlling flaws observed in these specimens were surface and internal pores, shown in Figure 155.

Figure 155. Typical strength-controlling flaw
(internal pore) observed in GTE AY6-405 sintered
 Si_3N_4 blade test bars.

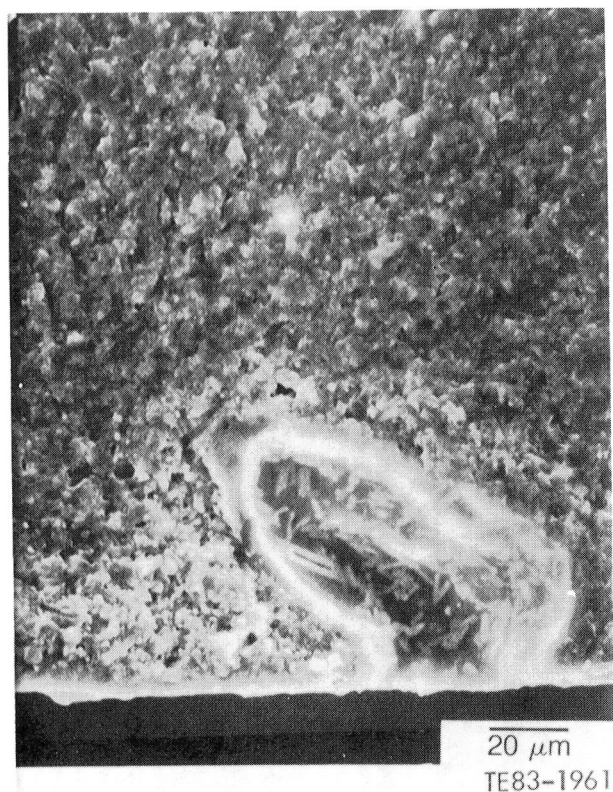
After oxidation for 100 hr at 1000°C (1832°F), the strength of the as-fired test bars dropped to 439.07 MPa (63.68 ksi), while the strength of the machined bars decreased to 474.72 MPa (68.85 ksi). Further decreases in strength after exposure at 1150°C (2102°F) were observed in both the as-fired and machined bars, which measured 405.98 MPa (58.88 ksi) and 388.33 MPa (56.32 ksi), respectively. The increases in strength observed after oxidation at 1250°C (2282°F)—450.17 MPa (65.29 ksi) as-fired and 473.96 MPa (68.74 ksi) machined—were attributed to the formation of a thin, glassy layer on the surface of the bars, shown in Figure 156. This layer was not seen after exposure at either 1000°C (1832°F) or 1150°C (2102°F).

Figure 156. Typical failure origin (surface pore) observed in GTE AY6-405 Si₃N₄ test bars after exposure at 1250°C (2282°F) for 100 hr; a thin, glassy layer developed on the surface of the pore.

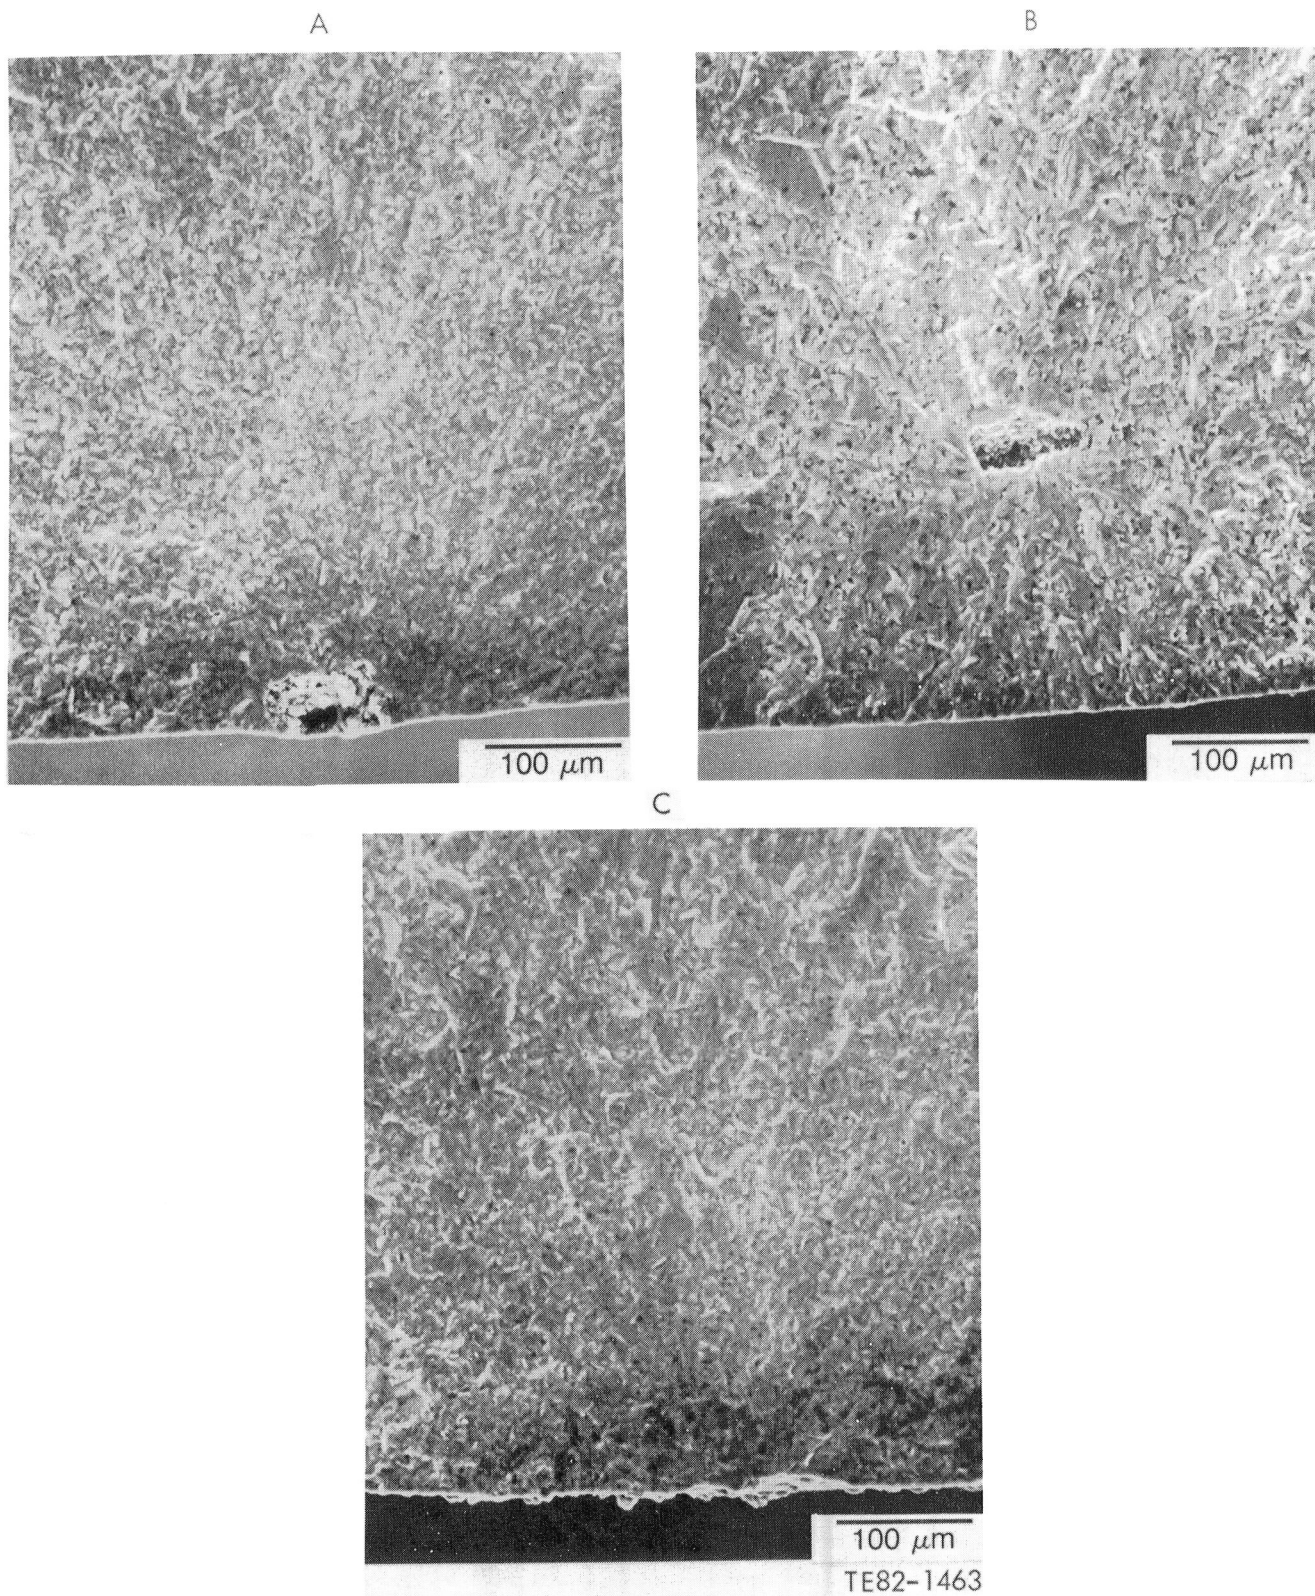
The average room-temperature fracture strength of 100 bars tested with a longitudinally ground surface condition was 418.87 MPa (60.75 ksi) with a standard deviation of 70.19 MPa (10.18 ksi). The primary strength-controlling defects observed in these specimens were internal pores (54%), with the secondary defects consisting of surface pores (34%) and surface flaws (12%). Typical examples of these defects are shown in Figure 160. A two-parameter Weibull analysis of the strength data provided a characteristic strength of 447.83 MPa (64.95 ksi) with a Weibull modulus (m) of 7.1, as shown in Figure 161.

Figure 160. Examples of typical strength-controlling defects in CBO sintered SiC blade test bars: (a) surface pore, (b) internal pore, and (c) surface flaw.

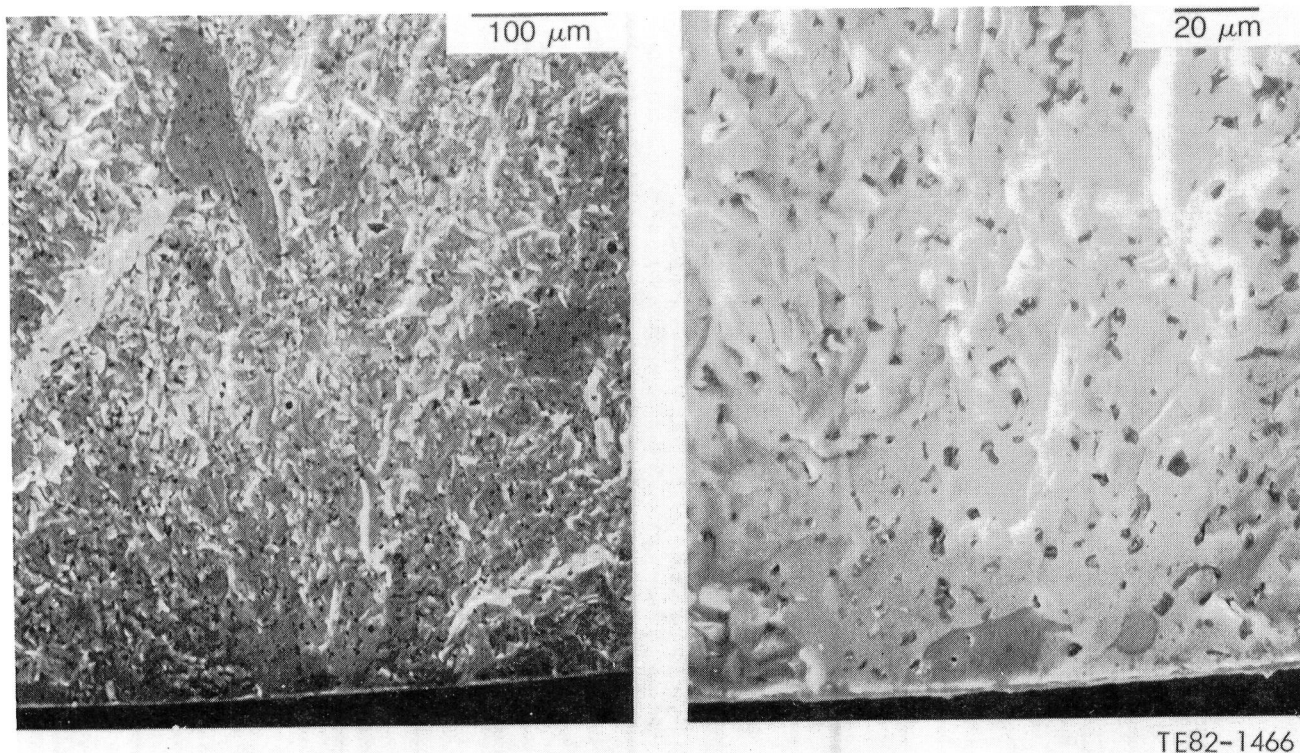
Figure 163. Strength-controlling defect (large surface crystal) observed in oxidized, transversely ground CBO sintered alpha SiC blade test bar.

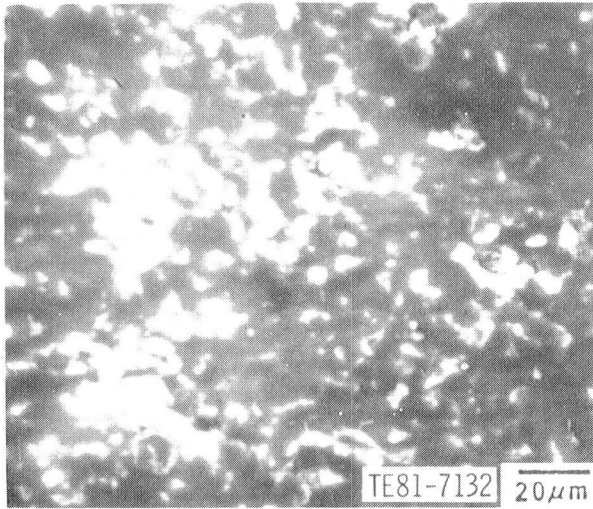
The average room-temperature fracture strength of heat-treated qualification bars with an as-fired surface condition measured 244.00 MPa (35.39 ksi) with a standard deviation of 7.32 MPa (1.06 ksi). This represents a 78% increase in strength over untreated test bars with as-fired surfaces. A thin, glassy layer of silica (SiO₂) was observed on the oxidized as-fired tensile surface, shown in Figure 168.

Figure 168. Photomicrograph of the surface of CBO RBSiC test bar with an as-fired surface condition heat treated at 1250°C (2282°F) for 24 hr.

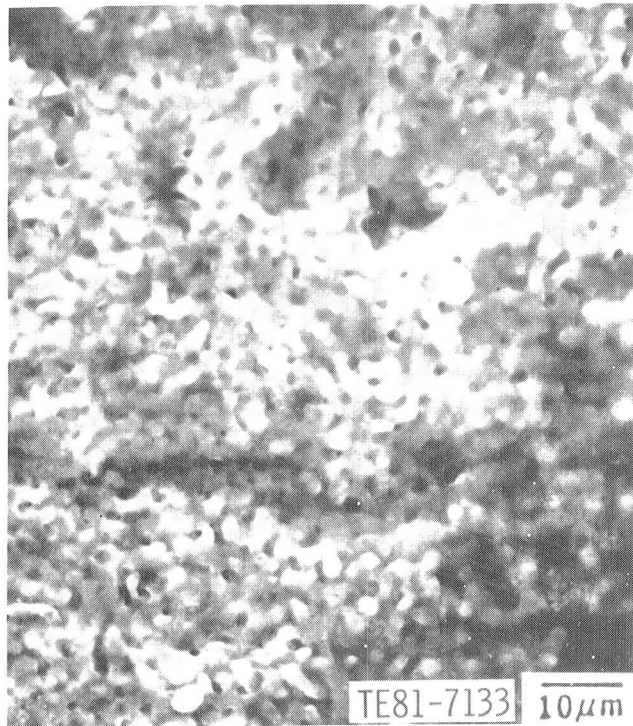
thin, glassy layer was again observed on the oxidized tensile surface, as in Figure 169.

Figure 169. Photomicrograph of the surface of CBO RBSiC test bar with a transversely ground surface condition heat treated at 1250°C (2282°F) for 24 hr.

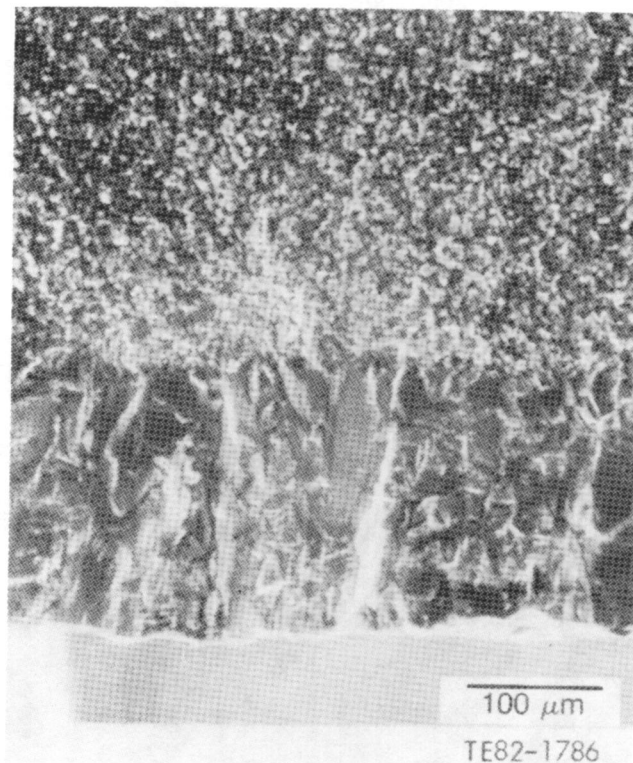
Of the seven rings that failed at pressures below the design level of 5170 kPa (750 lb/in.²), three were observed to have fracture origins located at relatively thick (150-200 μ m) layers of silicon-carbide crystals on the ring outside diameter, as shown in Figure 172. These crystals were similar to those previously observed in the as-fired qualification test bars, which exhibited strengths of only 100.00 MPa (14.51 ksi). Carborundum identified the source of this phenomenon as a crack in the graphite tube of the vacuum induction furnace used to fire these components. This resulted in localized hot spots in the sintering furnace which promoted exaggerated grain growth on the surface of these rings. This problem has since been resolved by the replacement of the defective tube and the incorporation of additional inspections after firing.

Figure 172. Microstructure of the outside diameter of CBO RBSiC outer vane support ring, showing SiC crystal layer.

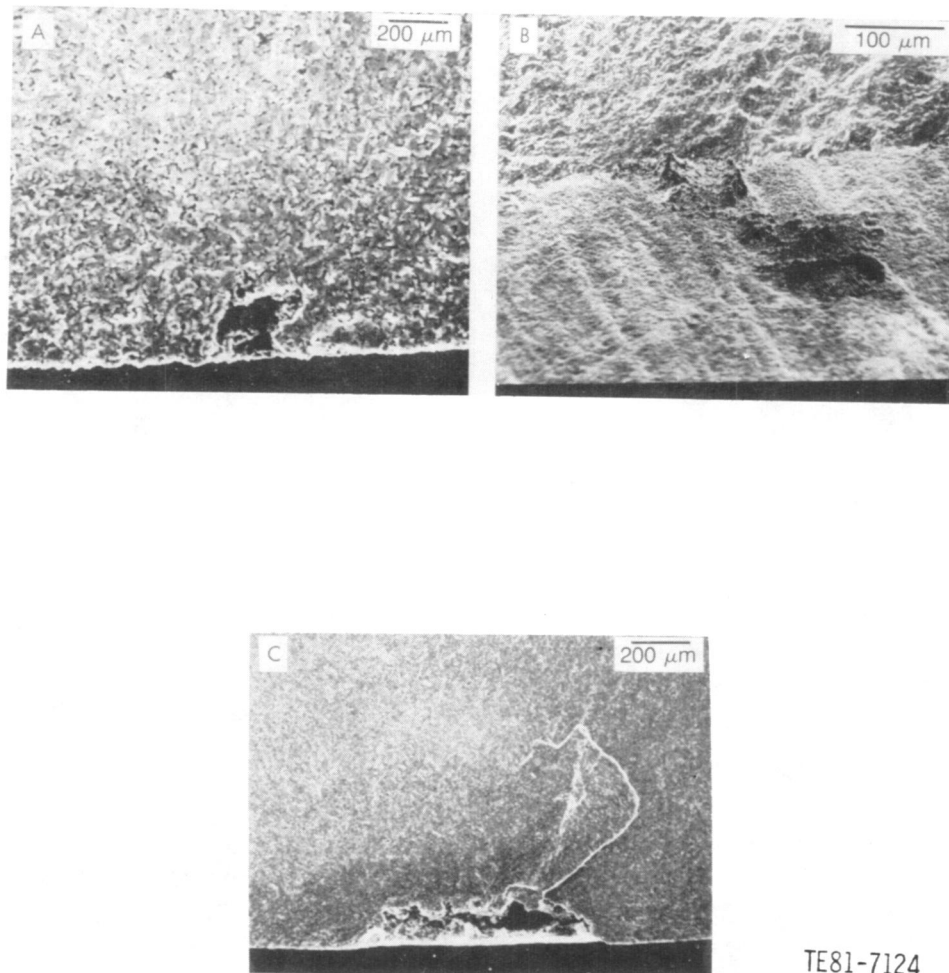
The accompanying qualification test material possessed an average density of $2.93\ \text{g/cm}^3$. A relatively low strength was observed in the plenum test bars, with an average room temperature MOR for the as-fired surface condition of $220.43\ \text{MPa}$ ($31.97\ \text{ksi}$) with a standard deviation of $41.92\ \text{MPa}$ ($6.08\ \text{ksi}$). Failure analysis of these test bars indicated that all fracture origins were located at surface sites, generally at large pores or surface blisters, as in Figure 175. The average MOR for test bars with a machined surface condition measured $333.78\ \text{MPa}$ ($48.41\ \text{ksi}$) with a standard deviation of $60.12\ \text{MPa}$ ($8.72\ \text{ksi}$). This represents a significant increase in strength for the machined bars versus the bars with an as-fired surface. Most fracture origins for the machined bars were at surface flaws or cracks, as in Figure 176, as opposed to surface pores and blisters for the as-fired specimens.

Figure 175. Typical strength-controlling flaws for as-fired CBO alpha SiC plenum test bars: (a) small surface pore, (b) surface blister, and (c) large surface pore.
